Oversized HDPE Liners to Combat Internal Corrosion & Erosion in Mining Industry Pipelines

18th International Conference on HYDROTRANSPORT
Rio de Janeiro, Brazil; 22 – 24 September 2010

Paper by Jim Thorne and Associates
Presentation by Jim Schmitz
NBS Incorporated

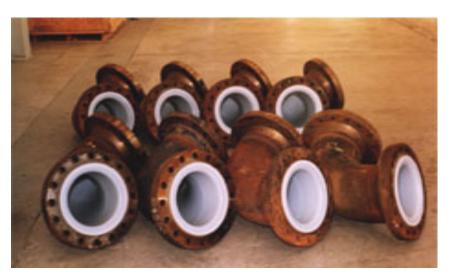
Bends and Roto-Lining Solution

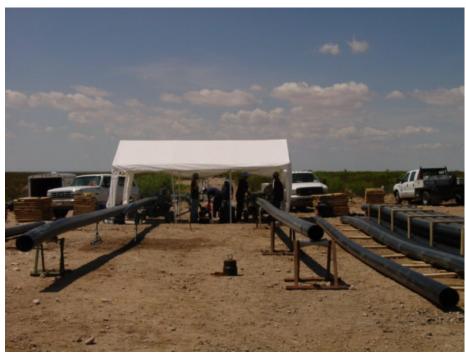
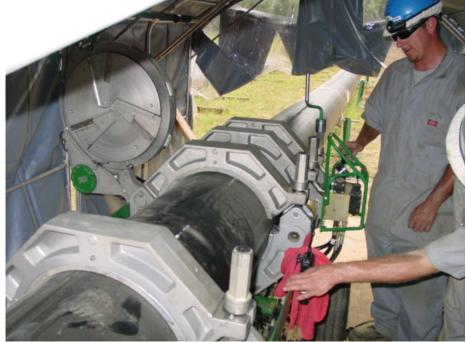
On site HDPE fusion to customized lengths of steel pipe

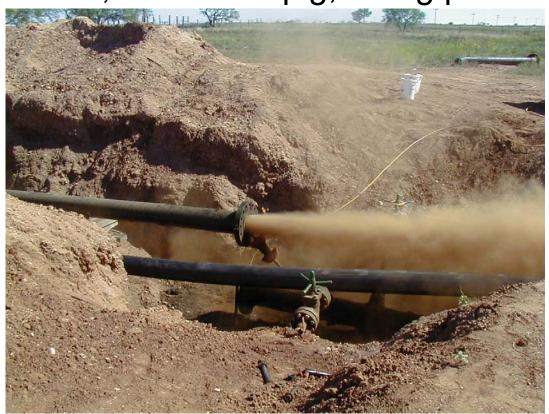
On site HDPE fusion to customized lengths of steel pipe

• Wireline cable, blowdown pig, sizing plate

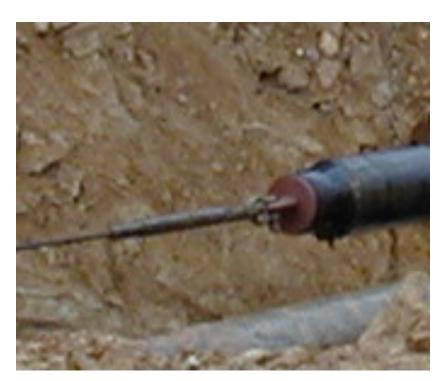
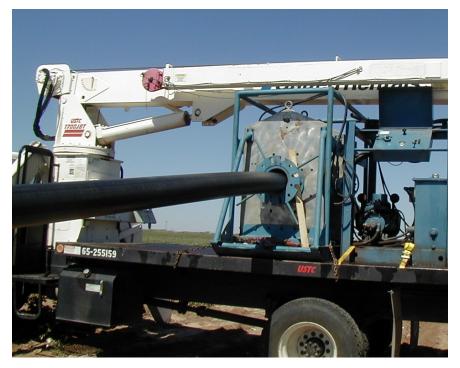
Customized material and Specialized equipment

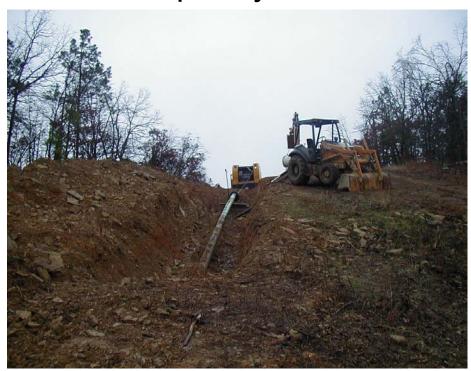
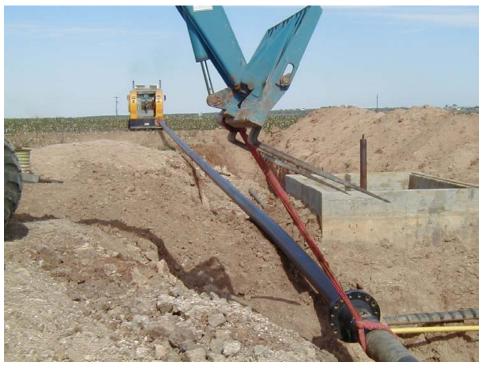
During this brief time of reduced diameter, the HDPE liner is quickly installed to line the host pipe

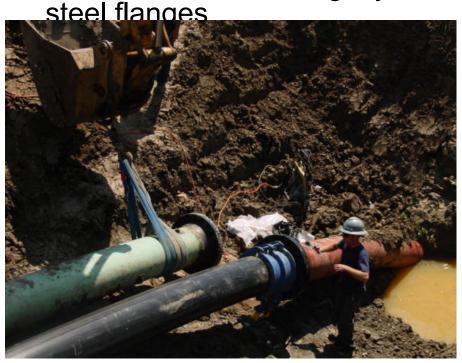
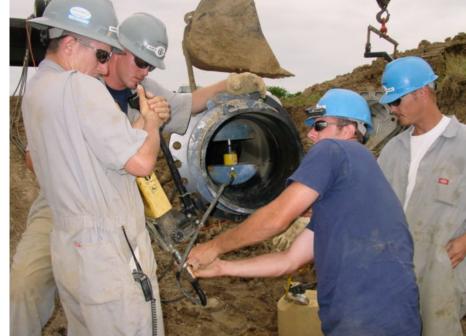
Internal and external clamps are then used to facilitate the installation of the HDPE end connections or "stub-ends" that are custom machined to tightly match the specially machined RFWN

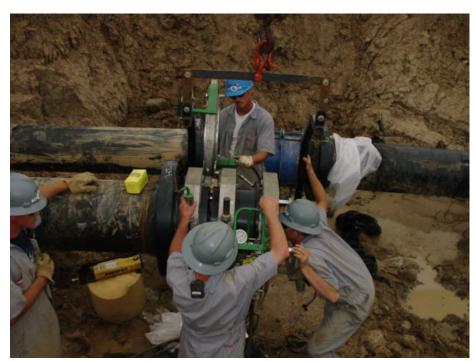
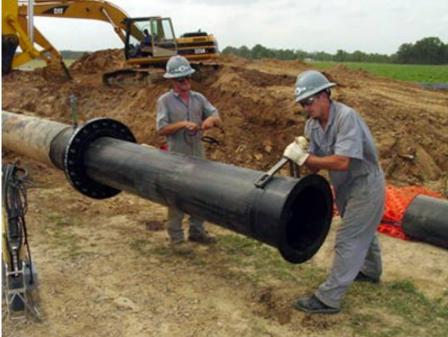
Fusion of stub-end, removal of internal/external weld bead, release of internal clamp

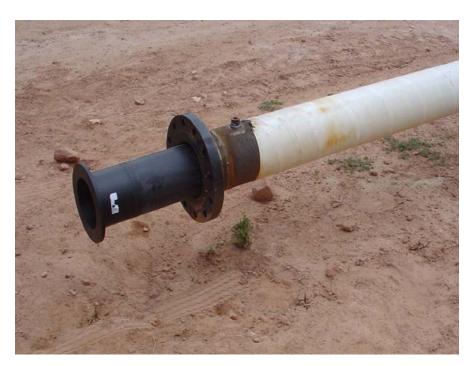
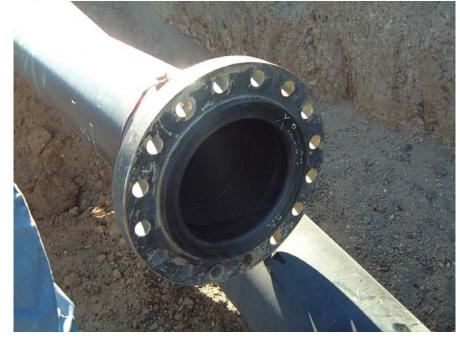
Relaxation/tightening of oversized HDPE liner, airtest, and bolt-up.

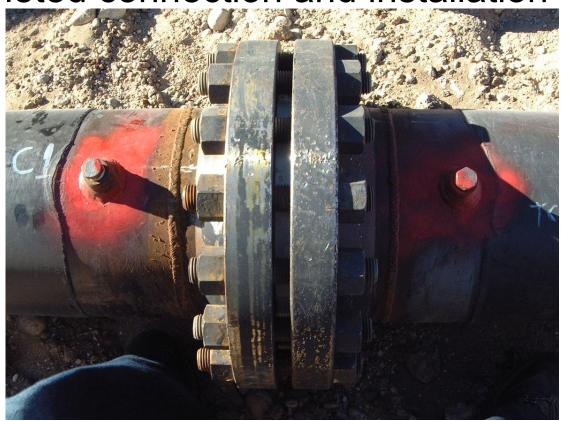
Completed connection and installation

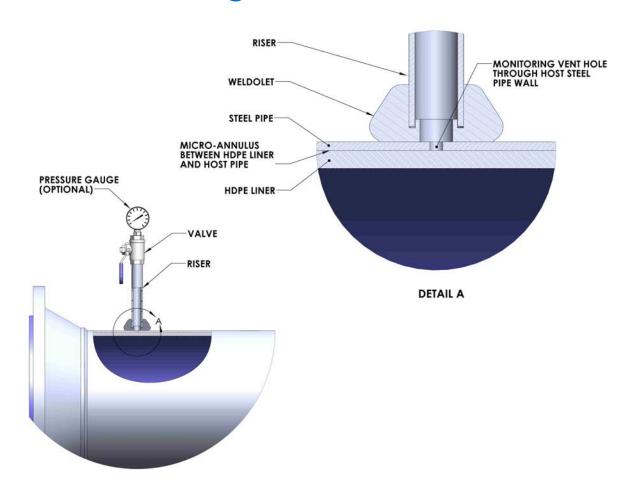
External monitoring vent

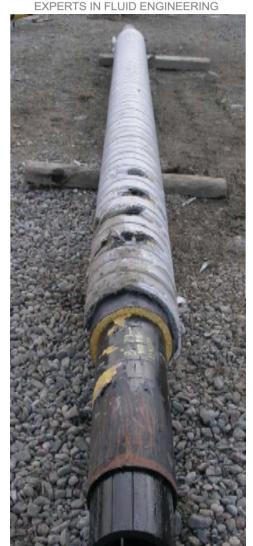
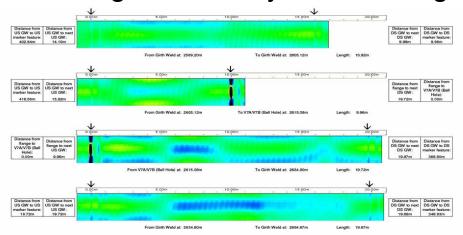
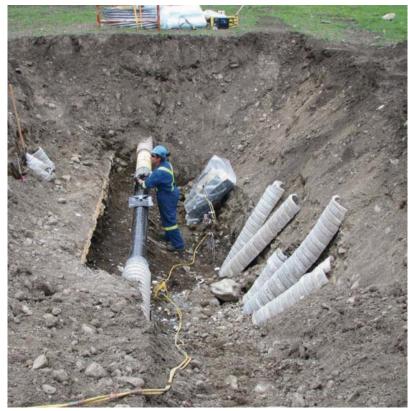
- 8-inch Steel Pipe
- Sour gas transportation
- Age = approx. 5 yrs old
- External concrete jacket
- HDPE lined
- 16.5km x four segments

- No major wall loss detected
- Lines are in good condition
- No immediate threat to surroundings
- Findings backed by selective digs

RFT information by Russell NDE Systems

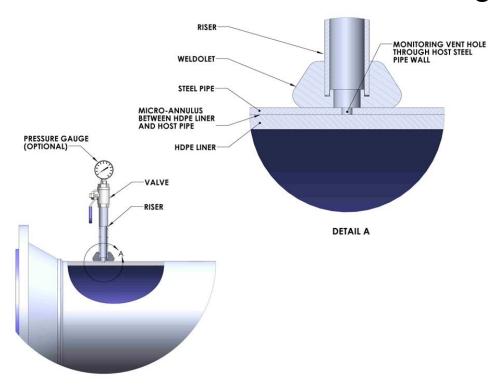
Leaks and Leak Detection – Monitoring Vents
